Using the Latest ILLI Technologies to Identify Pipeline Pilferage

Andrea Bologna, TECMA Srl

September 16, 2019

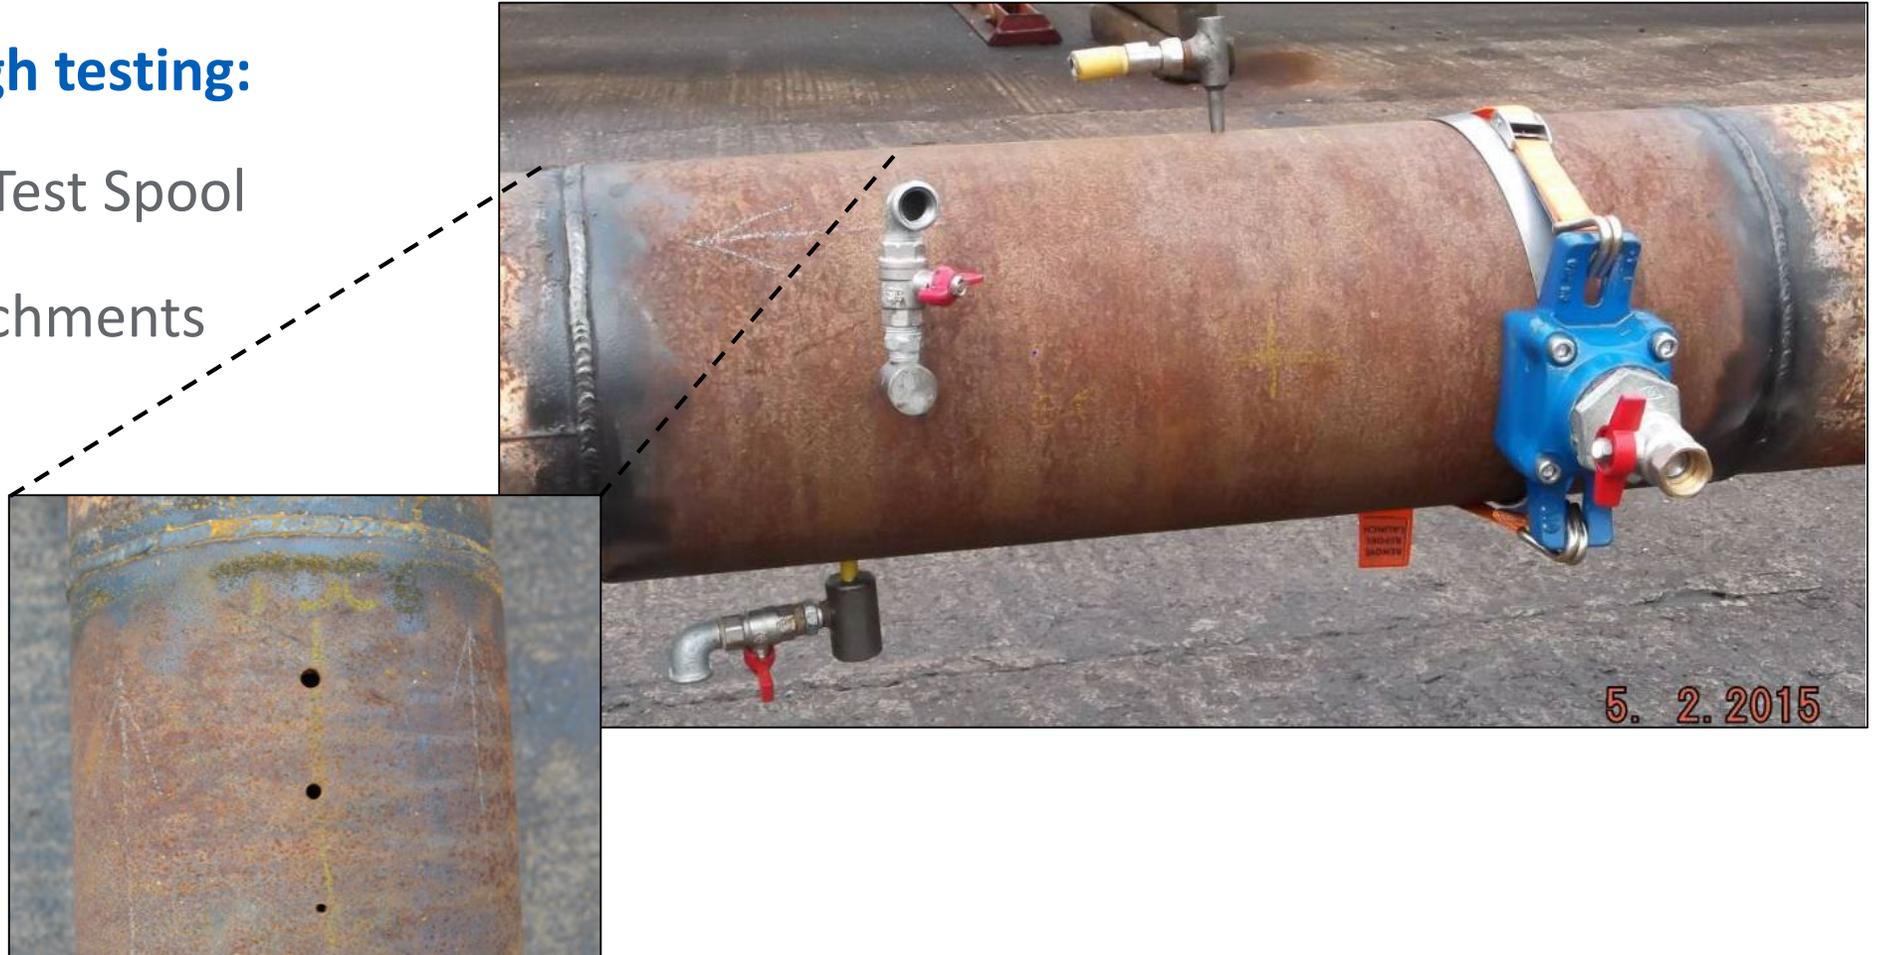
Tecma Supplied Test Spool

- 4 Ferrous Attachments
- 3 Drill Holes

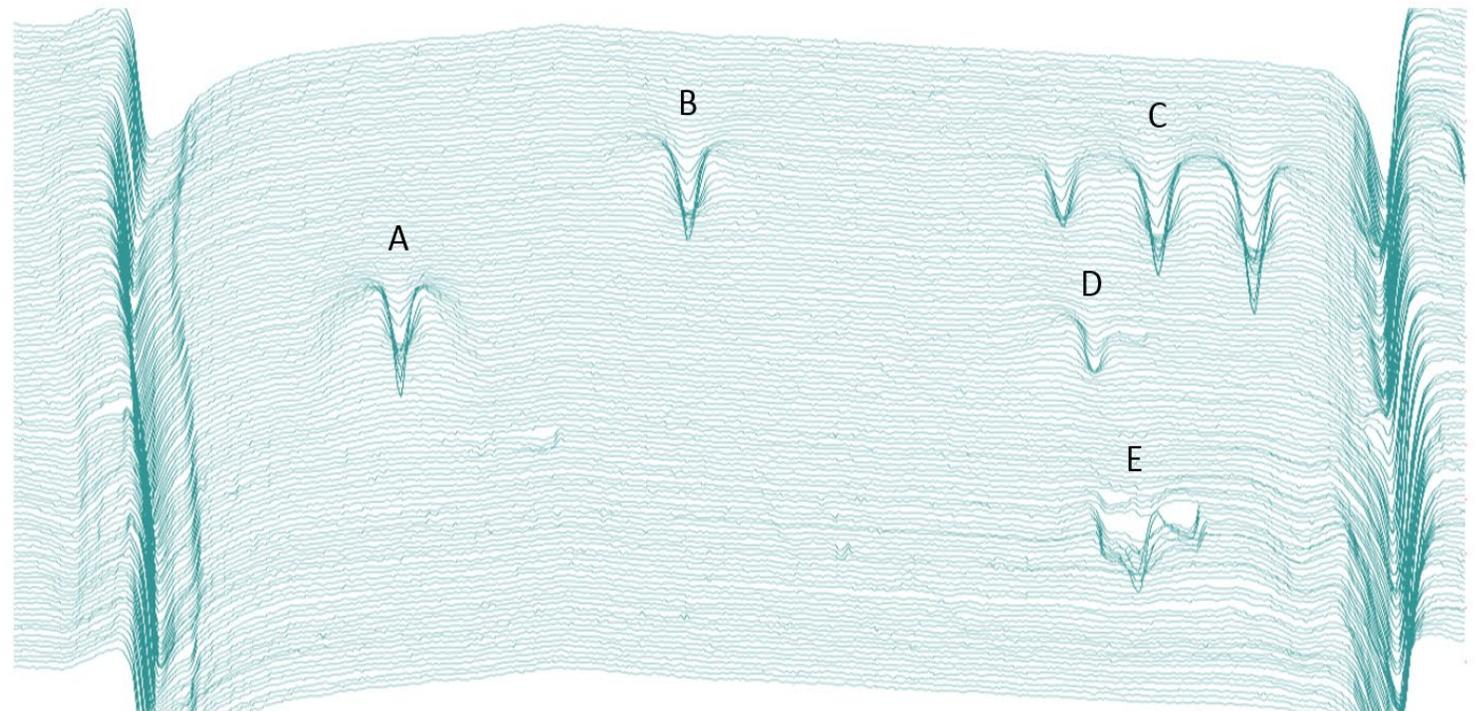
Multiple pull-through tests were carried out using BHGE's 10" New MagneScan inspection vehicle to assess the tool's ability to detect the features.

All seven features were identified during each pull-through test.

- A. Cast Iron Tap
- B. & D. Ferrous Attachments
- C. Drill Holes
- E. Protruding Attachment

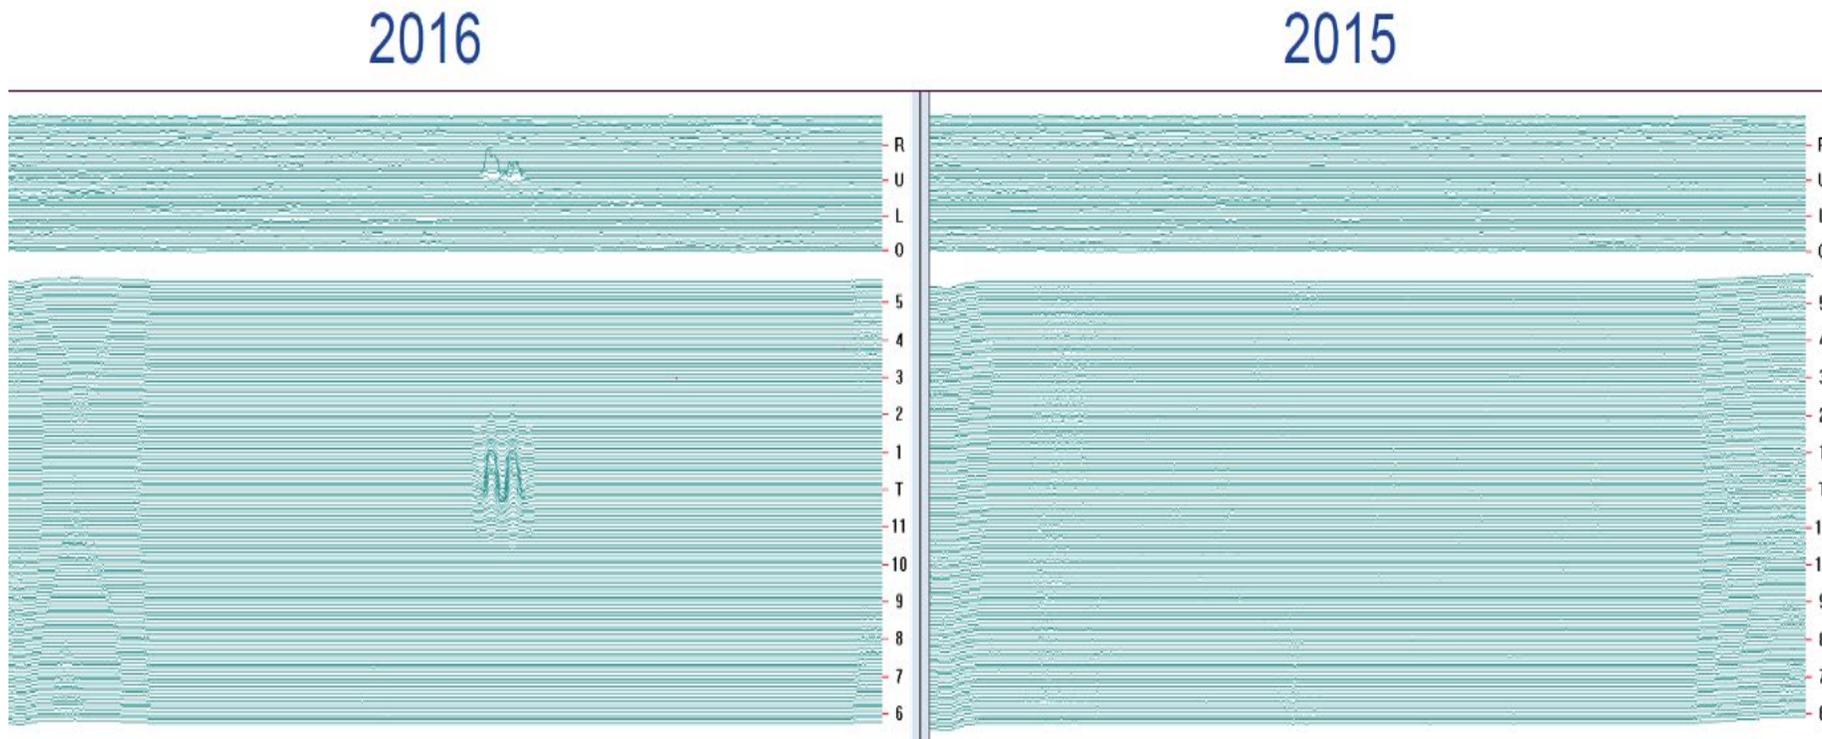
Two attachments were identified under a pipeline casing, near to a river crossing. These attachments were new compared to the previous inspection, carried out in 2015.

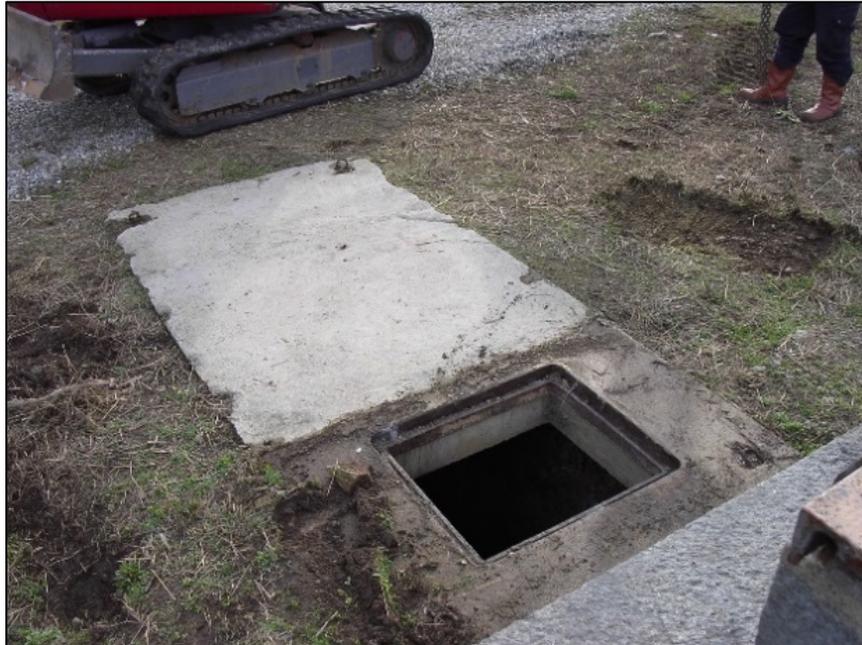
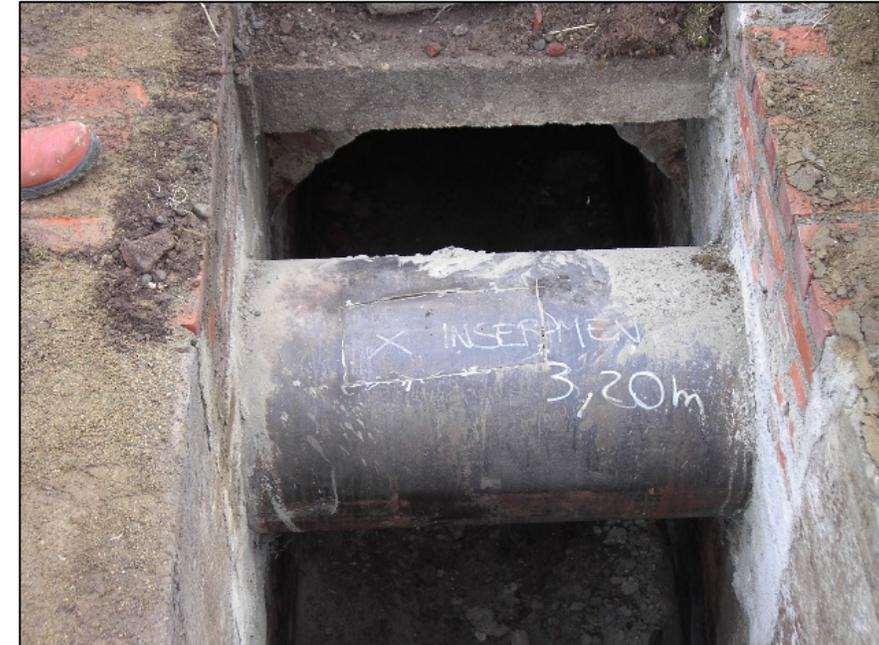
The excavation highlighted the elaborate attempts of the thieves to disguise their illegal activity from visual discovery by the pipeline operator or members of the public.

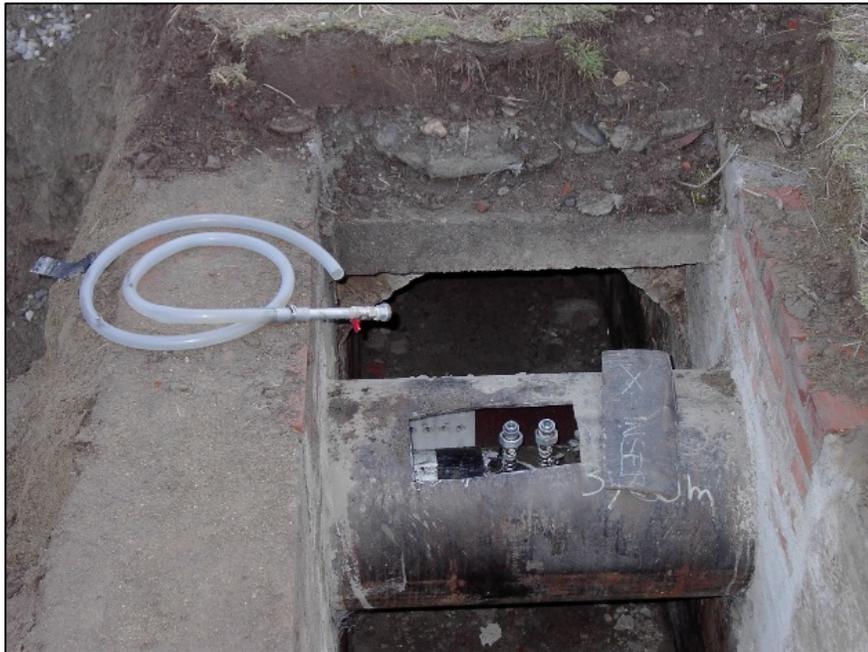
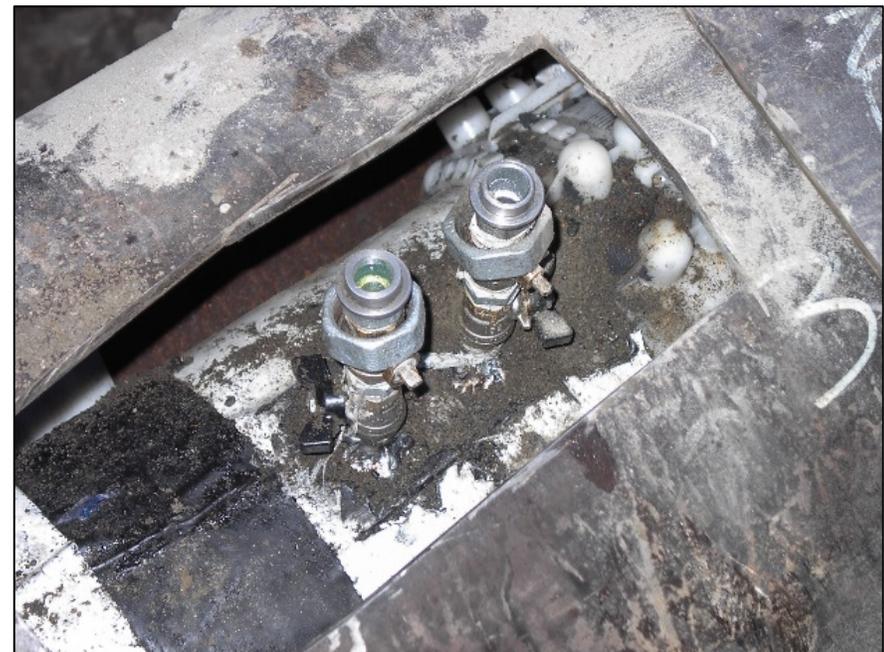
Despite the thieves' elaborate attempts to avoid detection, the obvious indications between the two inspection data sets allowed the pipeline operator to find these illegal taps, which may have gone undetected through visual pipeline examination alone.

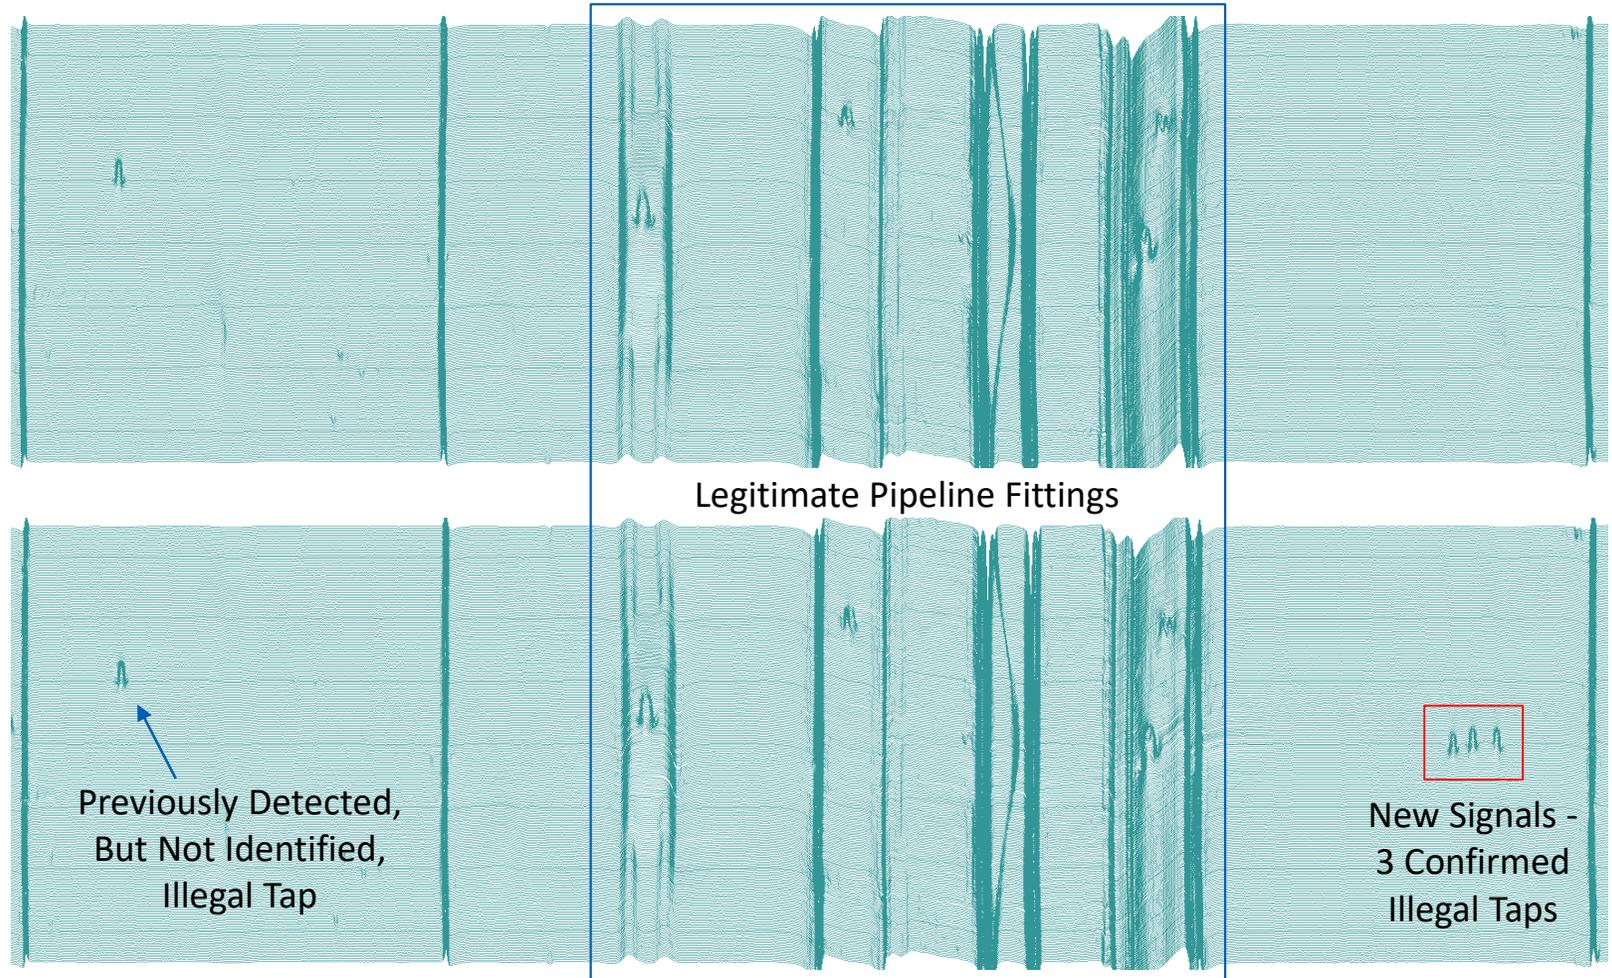
The fitting had been detected, but not identified, during the analysis of the first-time inspection because it did not look out of place.

The implications of this case study are the need for analysts to develop a suspicious mind and for pipeline operators to correlate inspection data with their own pipeline design and layout information.

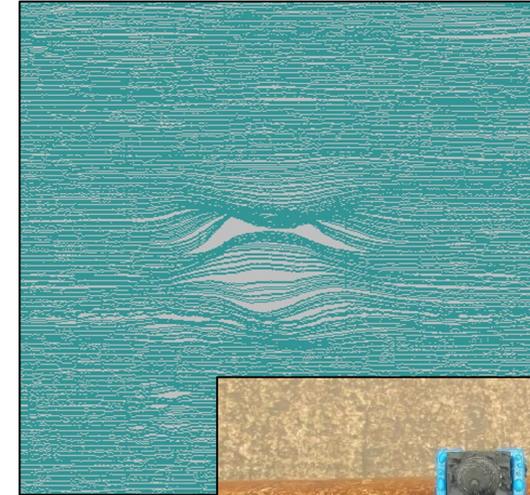
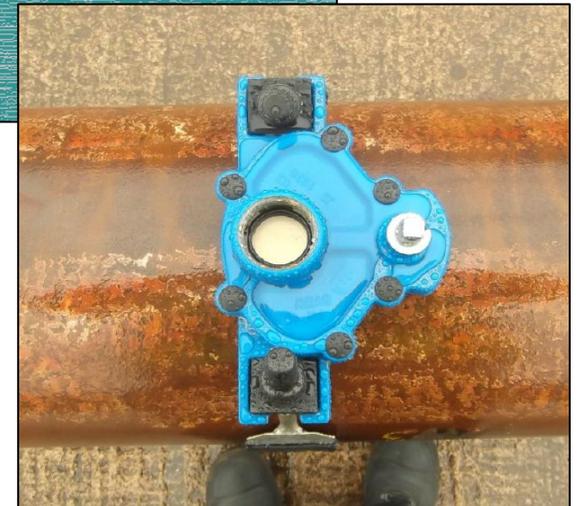
- All the tapping attachments were detected.
- The TFI inspection vehicle detected two small diameter through wall holes.

Illegal Tap detection could be incorporated into a TFI inspection, and the number of runs required by the operator was halved.
